DEPARTMENT OF TRANSPORTATION

Quality Assurance and Source Inspection

Contract #: 04-0120F4Cty: SF/ALA Rte: 80 PM: 13.2/13.9File #: 69.28**WELDING INSPECTION REPORT****Resident Engineer:** Pursell, Gary**Address:** 333 Burma Road**City:** Oakland, CA 94607**Report No:** WIR-001577**Date Inspected:** 03-Mar-2008**Project Name:** SAS Superstructure**OSM Arrival Time:** 1800**Prime Contractor:** American Bridge/Fluor Enterprises, a JV**OSM Departure Time:** 630**Contractor:** Zhenhua Port Machinery Company, Ltd (ZPMC), Changxing Island **Location:** Shanghai, China**CWI Name:** M.K. Wu**CWI Present:** Yes No**Inspected CWI report:** Yes No N/A**Rod Oven in Use:** Yes No N/A**Electrode to specification:** Yes No N/A**Weld Procedures Followed:** Yes No N/A**Qualified Welders:** Yes No N/A**Verified Joint Fit-up:** Yes No N/A**Approved Drawings:** Yes No N/A**Approved WPS:** Yes No N/A**Delayed / Cancelled:** Yes No N/A**Bridge No:** 34-0006**Component:** Bottom Plate**Summary of Items Observed:**

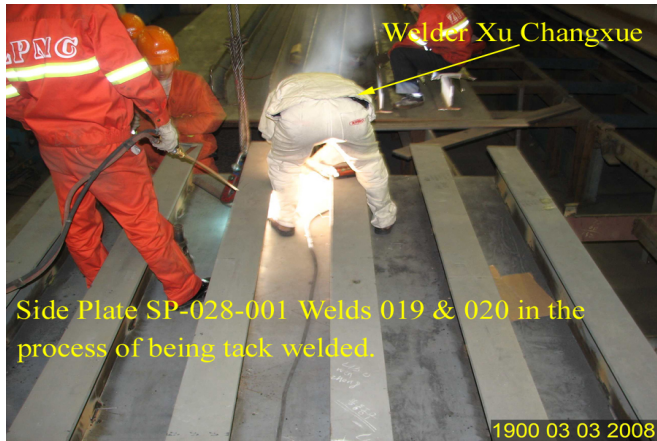
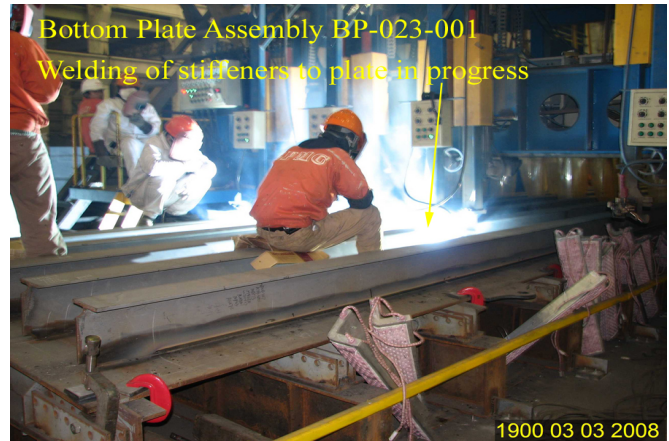
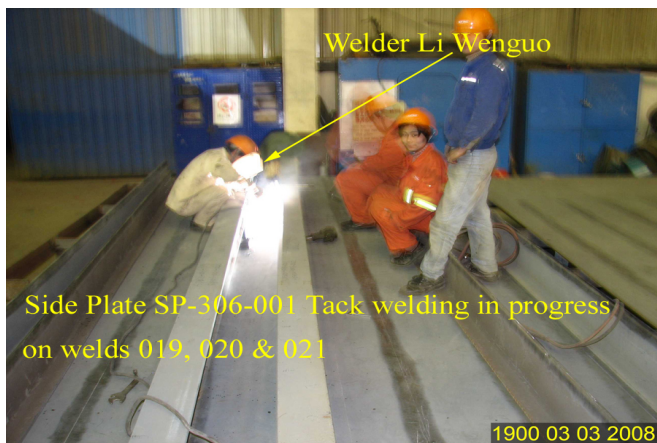
Bay-3, Bottom Plate Assembly BP-023-001 Stiffener welds to PL-79A #1 & 2, 3 & 4 and 5 & 6 were in the process of being welded by Zhenhua Port Machinery Company (ZPMC) Li Shuliang #048801 for 1 & 2, Sun Ti Yu #054459 for 3 & 4 and Liu Zihong #062447 for welds 5 & 6. The WPS-B-T-2132-3 was posted near by and the wire used was E71T-1. The CWI was M.K. Wu and the QC was Gui Yang Wei.

Bay-3, Side Plate SP-306-001 Stiffener welds to PL-913A #019,020 and 021 were being tack welded by ZPMC welder Li Wenguo #066261. The WPS-B-P-2112 was posted near by and the welding rods were TL-508 and the QC present was Wang Liang.

Bay-3, Side Plate SP-028-001 Stiffener welds to PL-87A #019 and 020 were being tack welded by a ZPMC welder XU Changxue #066002 using THJ 506 FE-1 welding rods. The WPS-B-P-2112-FCM was the procedure being used and was posted nearby.
